MASTER PLAN

JAMAICA ROYALE TOWER II ASSOCIATION, INC.

5830 Midnight Pass Road
Sarasota, Florida 34242

LCM Engineering, PLLC

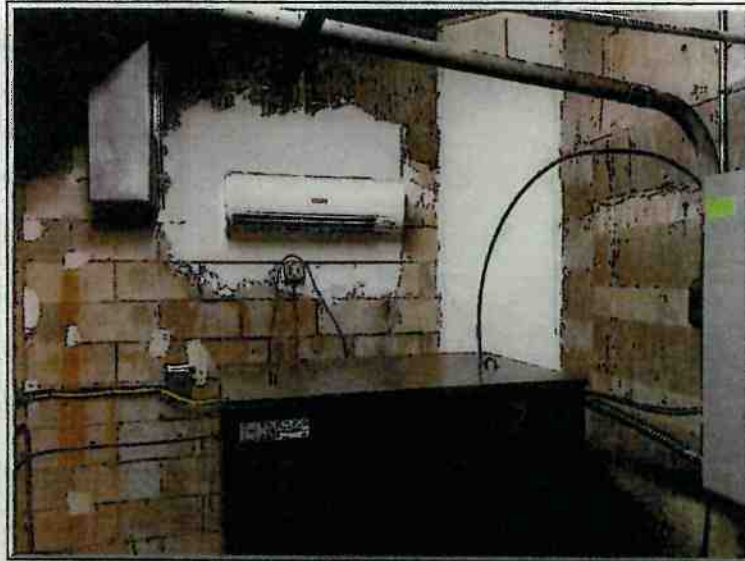
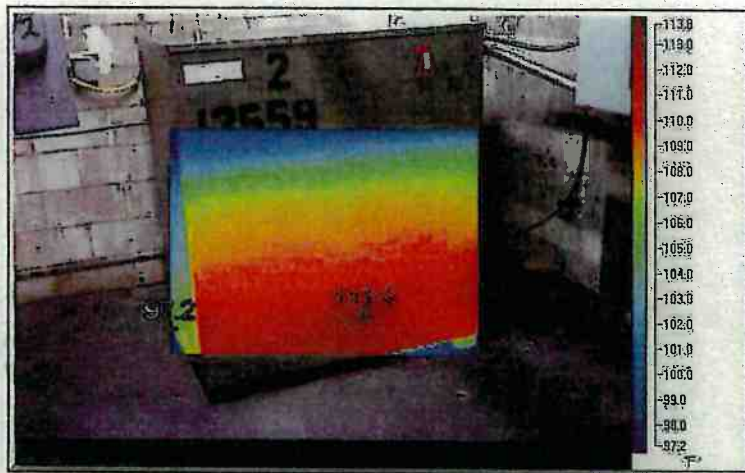
Transformer/elevator equipment room has a wall mounted mini-split a/c system. System is not currently running and is creating unusually high temperatures in the space. This A/C

unit is needed to temper the air in this room to get the maximum life expectancy out of the equipment, lower maintenance cost and insure continuous operation.

Recommended servicing mini-split A/C unit and bring up to proper working order. Recommended t-stat setting 80 degrees. Keep doors and openings to outside closed at all times. Replace A/C unit if necessary.

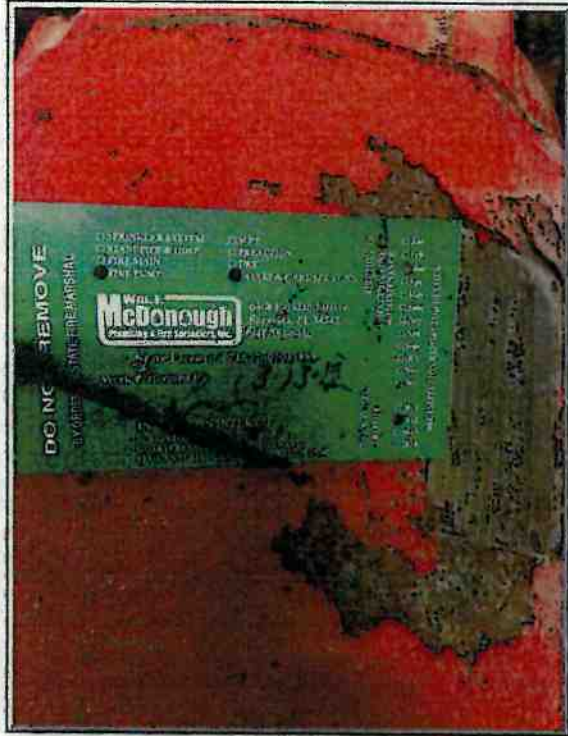
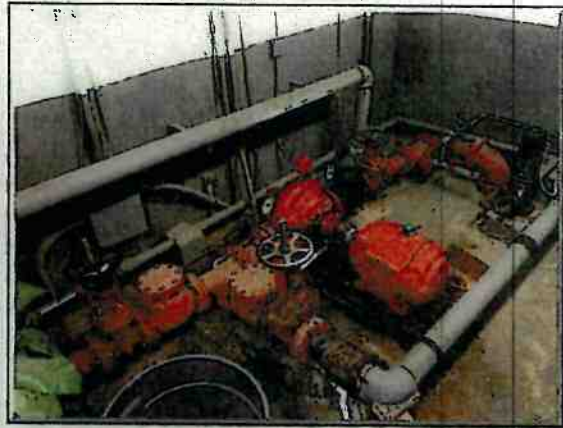
First floor fire and domestic water pump room. Fire pump appears to be serviceable but some parts are showing signs of aging beyond their useful life. Inspection tag indicates last

service date of 3-13-12, It is our recommendation that a certified fire flow test be performed once each year to ensure the proper working order of this equipment. Engineer recommends the replacement corroded or rusty parts and existing valves. The jockey pump and main pump be exercised on a regular basis to ensure proper working order.

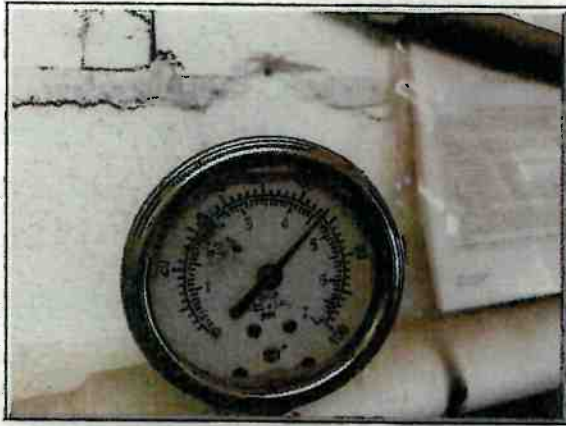
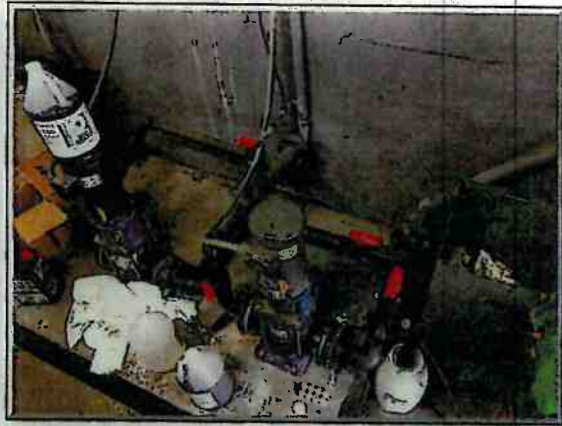
Domestic water booster pumping system is running on lead lag variable speed drives and appears to be in good working order. Pressure gauge indicates holding near 70 psi during time of light water usage.

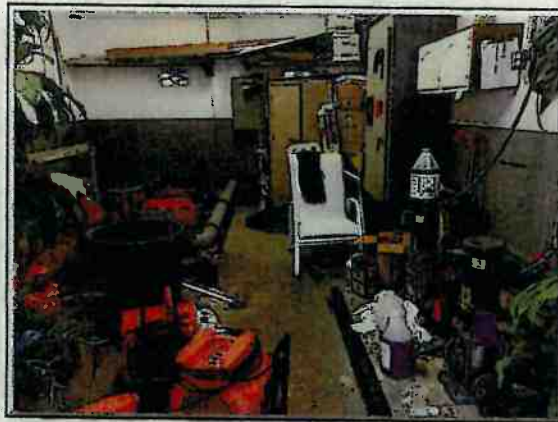
The general order of the pump rooms needs to be addressed. It is our recommendation that all items being stored on this area be removed immediately. Such as oil based solvents, furniture, cleaning supplies, cardboard boxes, trash bins, and appliances not related to the fire and domestic pumping systems. This will help prevent fires, short circuits and ensure ease of escape for individuals occupying this space for maintenance purposes.

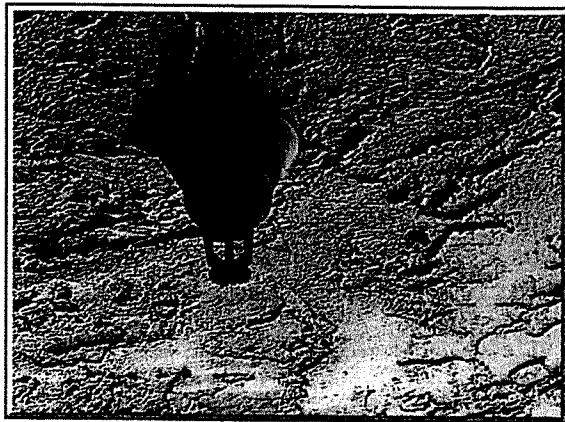
The sprinkler system only services critical areas of this building i.e. first floor parking, trash rooms and possibly elevator shafts (shafts not visible during this visit). Inspection of the sprinkler heads indicates existing heads are corroded and in need of replacement. Some currently installed heads may be part of a national recall list. This needs to be addressed by a certified fire protection contractor to ensure the replacement with new heads that have the proper response time glass bulb with the correct burst temperature for that location, as well as connection size to its threaded pipe and escutcheon covers. Photos below show existing sprinkler heads at sub living level parking spaces and trash rooms of different age, make, model and response type. Recommend replacement of all fire sprinkler heads in building.

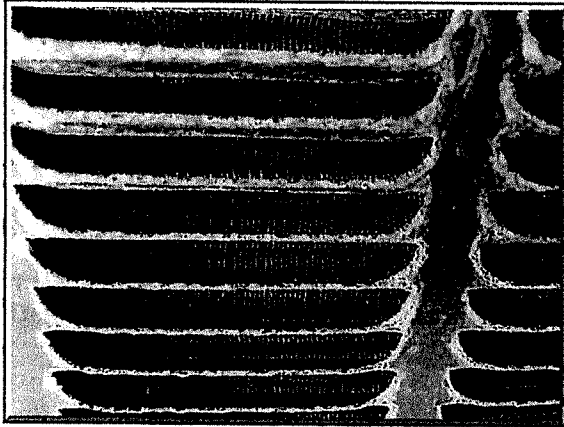
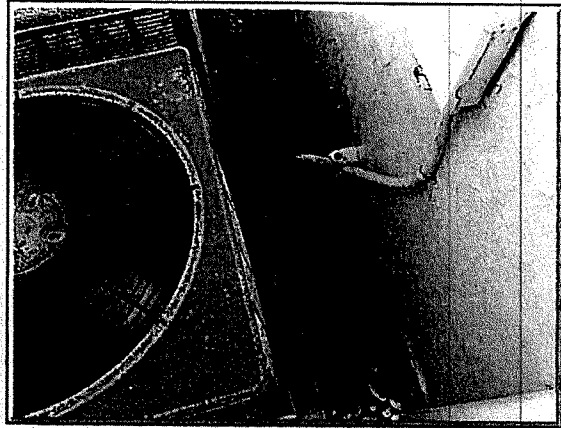
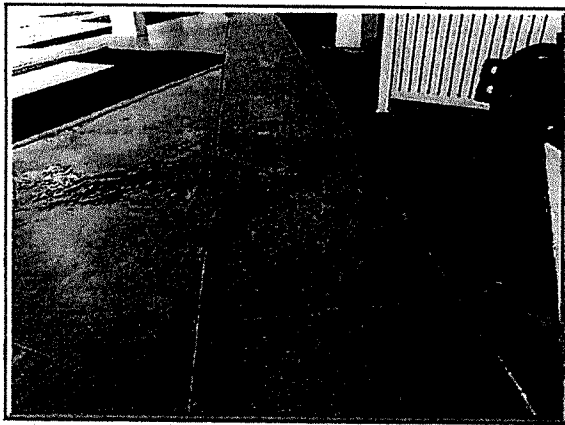
Discharge location of the existing condensate needs to be rerouted to the storm drain culvert or a planted area to prevent further property damage, such as seen in the photos below. You will notice the standing condensate water in the rock bed areas around the condensing units is causing premature corrosion on the condensing units adjacent to the electrical and pump rooms. Constant moisture is also causing algae to grow on the concrete walkways creating slip and fall hazards and paved parking areas to buckle. Repairs needed in parking space #605.

It is recommended that the condensate system be jetted clean by a licensed plumber and routine (non-chlorine) chemicals be added at each unit A/C drain connection quarterly to maintain system.

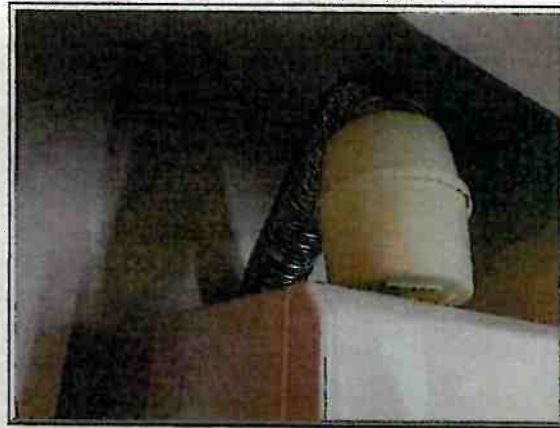
Some of the units inspected had stacked washer dryers added over the years. Some units such as the one in the photo below (unit #601) are connected to lint collection devices. Lint collection devices are not the first choice for disposing of dryer discharge air. These devices need lots of maintenance to prevent fires, discharge dust, lint and hot air into living spaces and are generally not accepted as a solution to dealing with dryer air discharge.

Engineer recommends Jamaica Royale Tower II Association, Inc. mandate all existing dryers configured this way, as well as future installations in the building, be routed to the outdoors using current Florida Building Code methods. Owners wishing to install a washer dryer in their unit also may want to consider a make a model washer dryer that is vent-less for the factory.

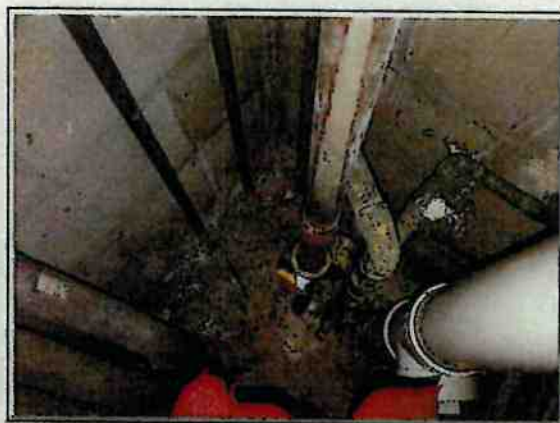
Domestic water piping on the first floor consists of mostly copper tubing with ball style shut off valves at the base of the risers. Located in the storage rooms, piping appears to be in good condition for its age. Some valves are showing signs of corrosion and lack of use. These valves also bare no tags indicating the unit numbers they serve.

Leaking domestic water pipes are imminent. Tagging valves with unit numbers can minimize confusion during emergency shut off times, minimizing property damage. Even a tagged valve is of no use, unless it is exercised quarterly to ensure and replace as needed.

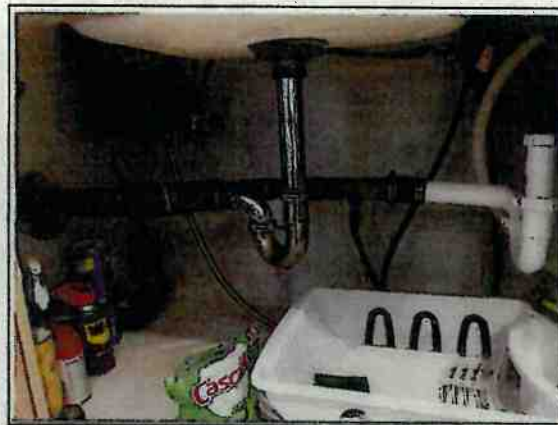
Sanitary pipes visible in units are a mix of PVC, cast iron and copper tubing. The photo below shows a kitchen sink in unit 306 consisting of PVC, polished chrome and copper tubing. The installation is holding up nicely for its age and draining with no leaks.

Engineer recommends replacing troublesome sanitary waste and vent stacks in like kind from roof vent down to ceiling ground level. Some board members may say much of the piping has been replaced already during renovations. Replacing from top to bottom will ensure the work is under one contract, warranty and contractor with no gaps, should a failure occur. Plumbing contractors will not typically warranty work they have not installed.

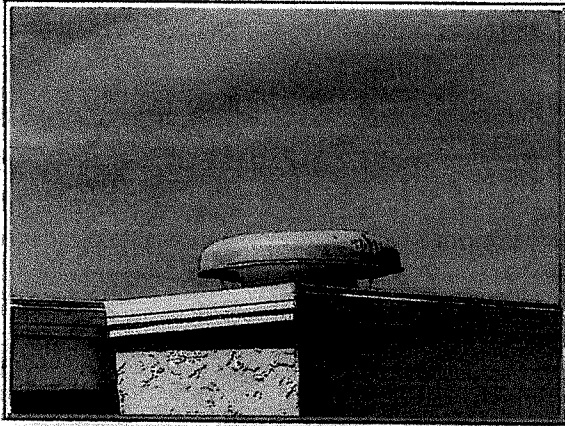
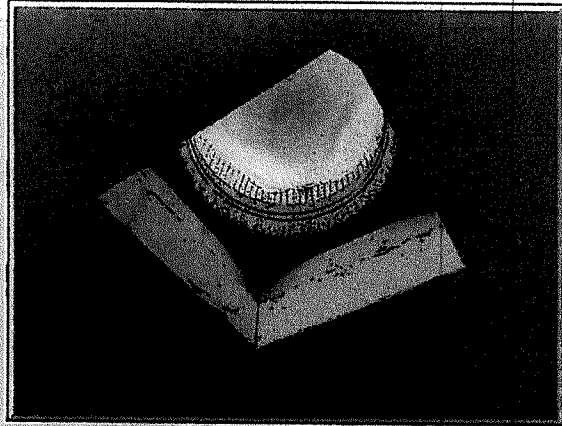
The photo below shows the stairwell ventilation opening at the 8th floor landing. Ventilation is by gravity means with intact bird screening and does a fare job of expelling heat through the top of the stair. Little signs of water intrusions inside exist.

If it becomes necessary to pressurize the stairwells, for code compliance, it can be accomplished easily by means of installing supply fans at the existing roof openings.

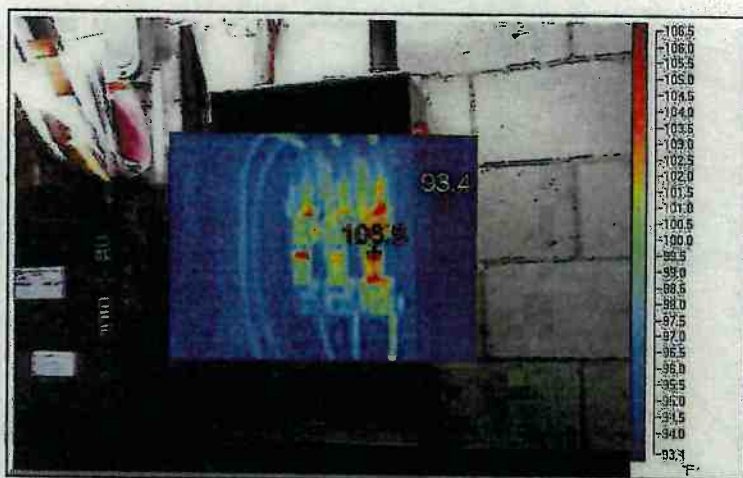
A thermal camera can visually locate intermittent or arcing junctions. Poor fuse connections are easily identified. The following image of a three-phase fused switch shows the “c” phase fuse noticeably warmer than the other fuses. The “c” phase load-side conductor also appears warmer than the “a” and “b” phase load-side wires.

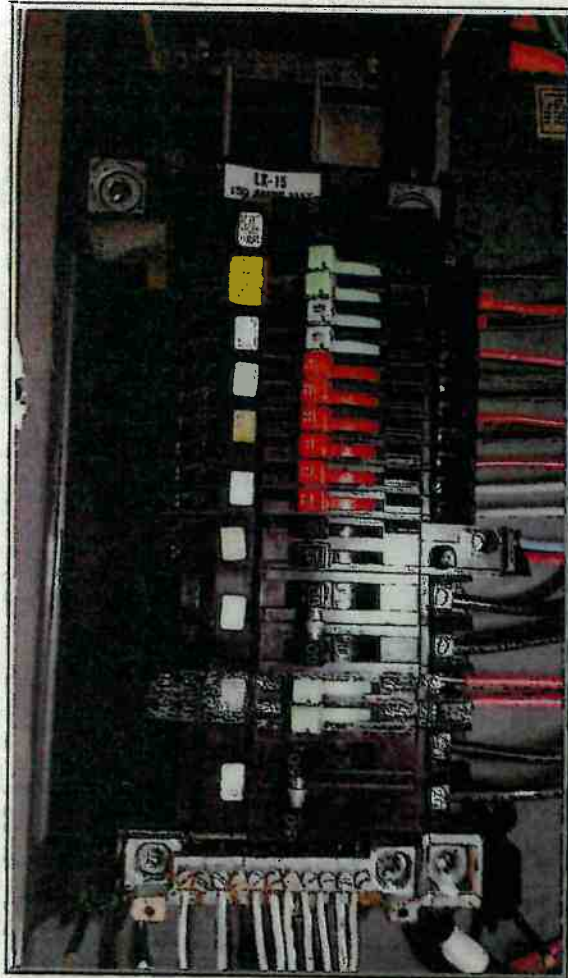
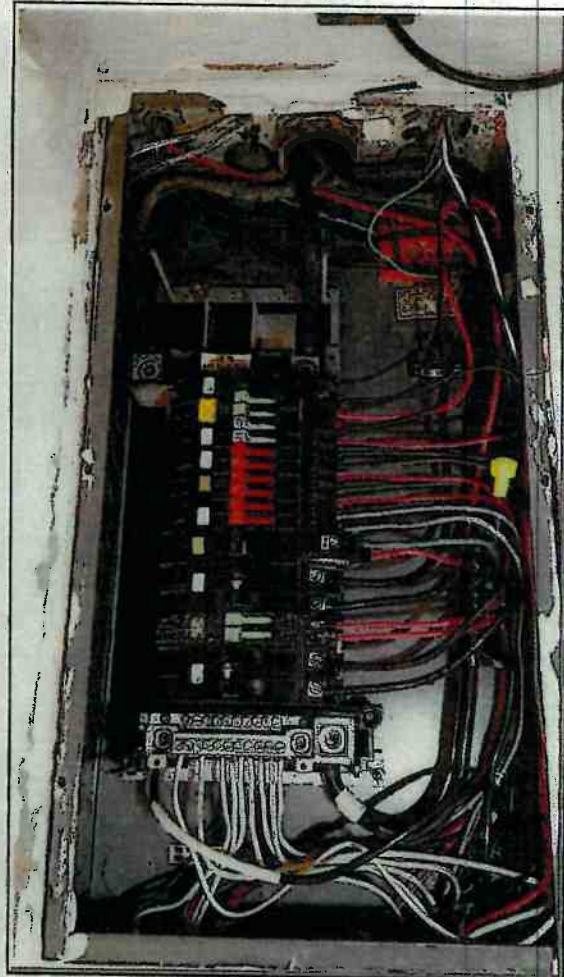
To observe conductor terminations and circuit breaker connections, we removed the panel cover to two individual unit load centers on each floor. We found no evidence of arcing or burning on the incoming 125-amp aluminum feeders, or on any of the branch circuit wiring extending from the load side of the breaker. We did not remove any breakers.

All of the panels observed had debris scattered in the bottom of the panel enclosure (see below); this should have been removed during commissioning of the original building.

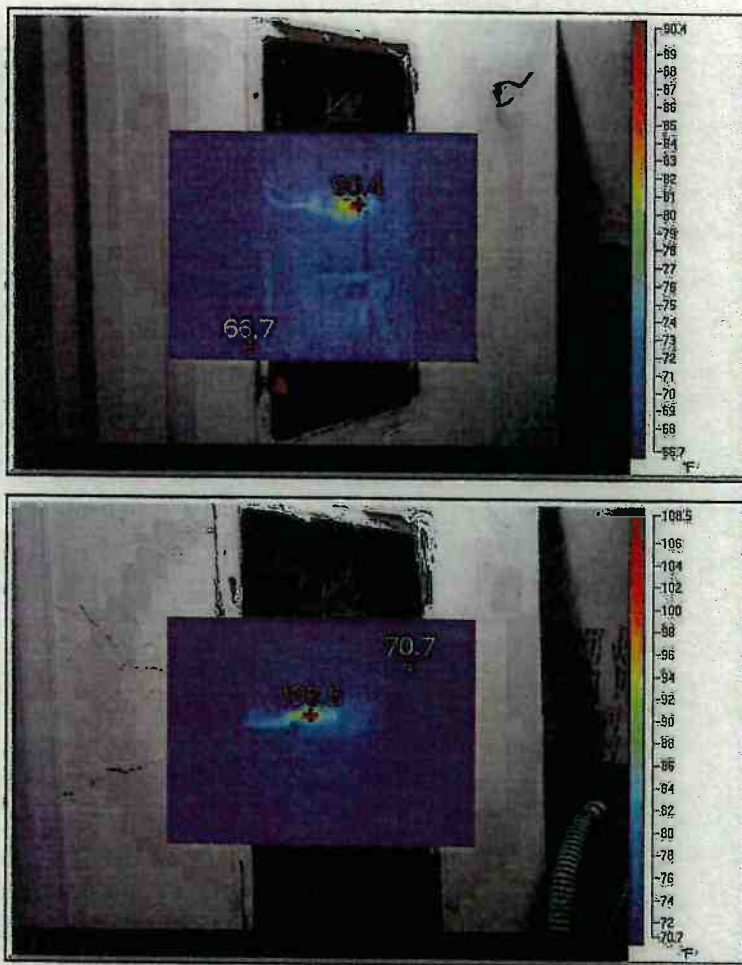
A clip-on ammeter attached around the panel feeders showed current measurements between 10 and 12 amps per phase for all panels measured. The bulk of this load was from the air-conditioning condensing unit. Thermal images of some of the electrical panels shown below illustrate this load activity. The noticeably warmer two-pole breaker shown below protects the outdoor condensing unit circuit. Clip-on ammeter measurements showed approximately 12 amps per phase in this circuit at the time of the photo.

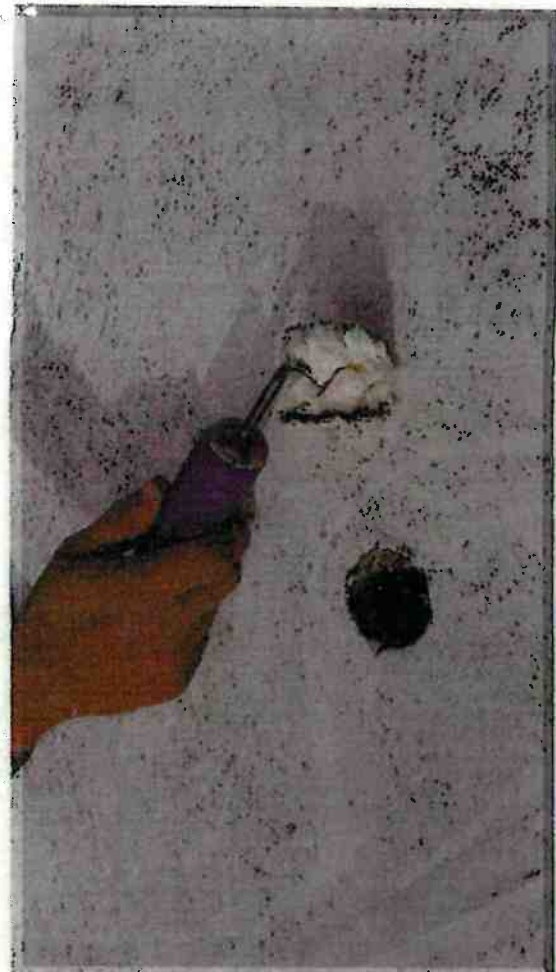
Photo 75 - 2" core showing membrane & insulation

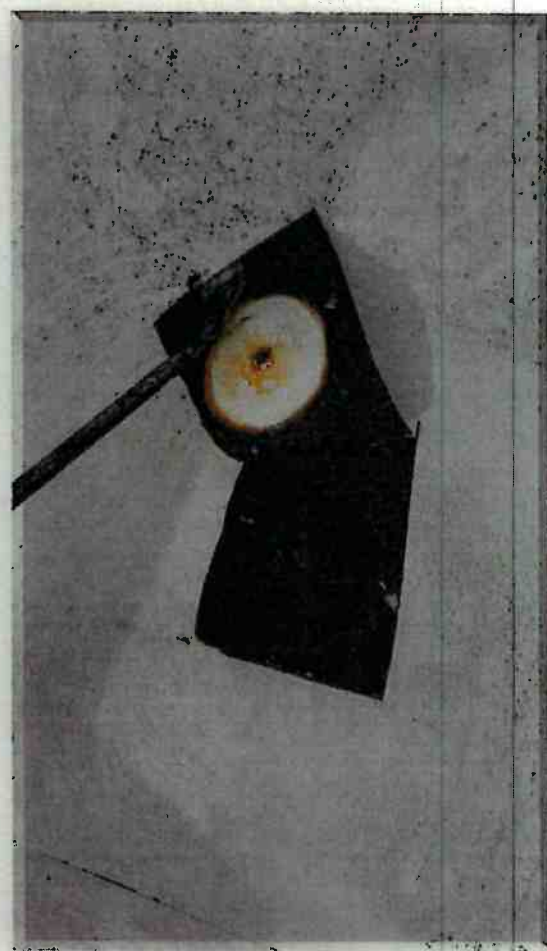
Photo 76 - Membrane glued to paper backing. Plate & screw fastening insulation to the concrete deck.

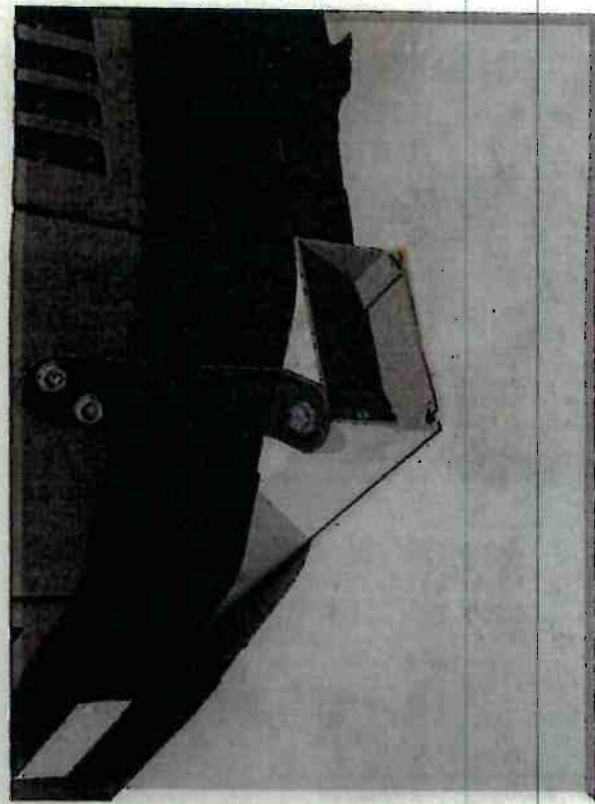
Photo 77 - Compressors are anchored to runners, but runners are not anchored to the roof.
