MASTER PLAN

JAMAICA ROYALE TOWER II ASSOCIATION, INC.

5830 Midnight Pass Road
Sarasota, Florida 34242

LCM Engineering, PLLC

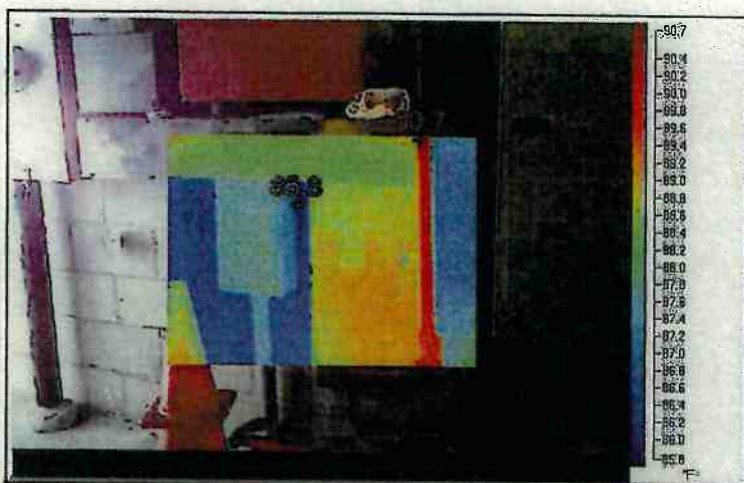
A thermal camera can visually locate intermittent or arcing junctions. Poor fuse connections are easily identified. The following image of a three-phase fused switch shows the “c” phase fuse noticeably warmer than the other fuses. The “c” phase load-side conductor also appears warmer than the “a” and “b” phase load-side wires.

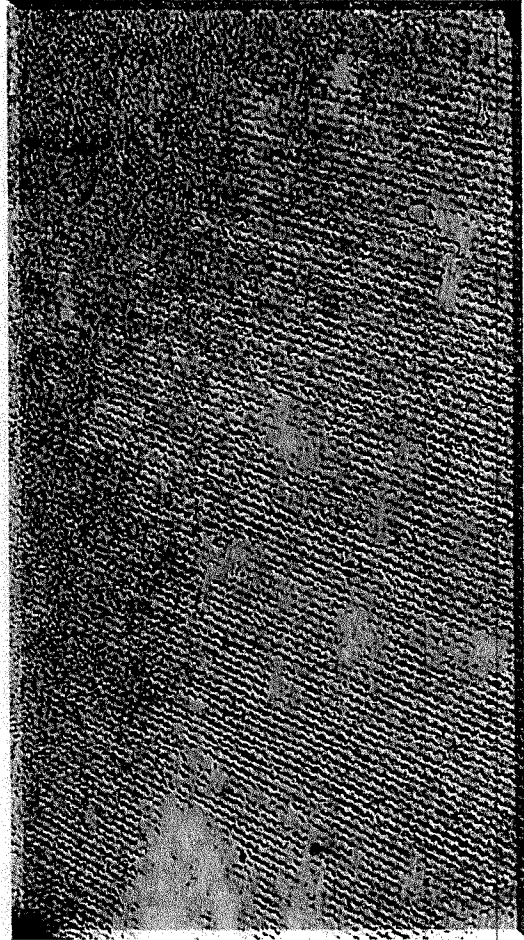
Photo #3 - Unit 803

The carpet is ragged, frayed and has separated from the waterproofing in many areas. The carpet is often wet for long periods. This has resulted in the carpet's blue color bleeding into the waterproofing and caulk on the walls, the door sealant and areas of the slab edge. The constant moisture is weakening the waterproofing seal against the walls and the slab edge. Evidence of sand, dirt and mold were observed where the carpet and waterproofing were separated.

LCM noted that the constant moisture from the carpet is causing the lower half of the metal door frames to rust. The moisture, from the carpets may also be blamed for the severity of the rusting window frames.

LCM recommends the Association remove the carpet. Removal of the carpet is not necessary, but its current condition degrades the aesthetics of the building. If the Association decides to replace the carpet, we recommend a higher quality carpet with better exterior weather performance be considered.

The cost to replace all of the walkway carpeting with like kind materials, on all of the walkways, is estimated at \$175,000.

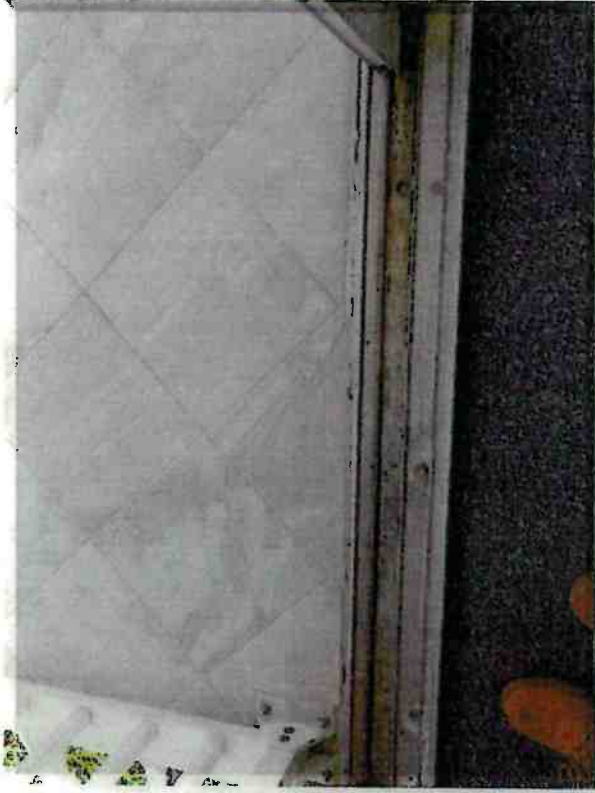
Photo #14 - Unit 601

Four of the units have tile on the balconies. From what LCM could determine, the tiles appear to be installed on top of the waterproofing. Many of the balconies have tiles that are debonded and loose. Four (4) Units had tile in their enclosures. Not all of the enclosures showed the waterproofing going underneath the enclosed sliding glass door tracks or interior tile. LCM also found obvious signs of standing water on tiled balconies.

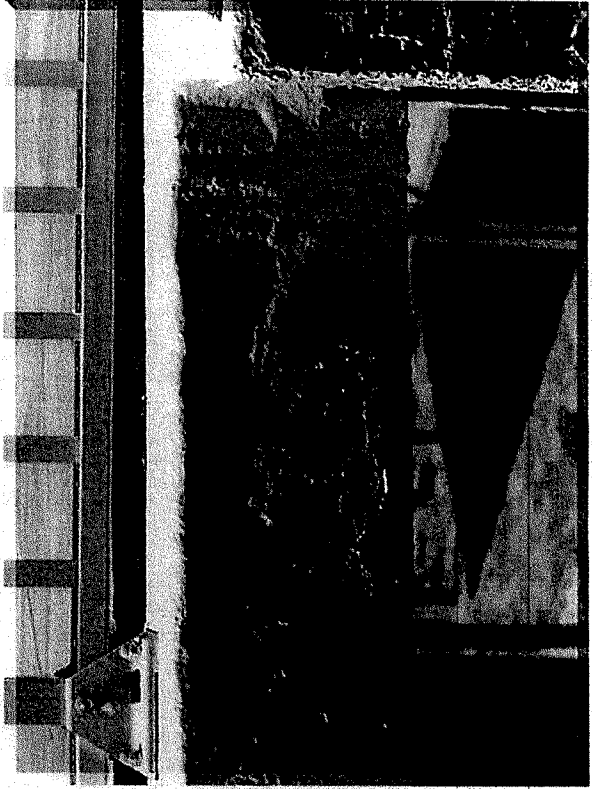
Photo #20 - Unit 806

Concrete Repairs - Slab Edge Repairs (Photos 19 to 21, 23, 24, 62, 66)

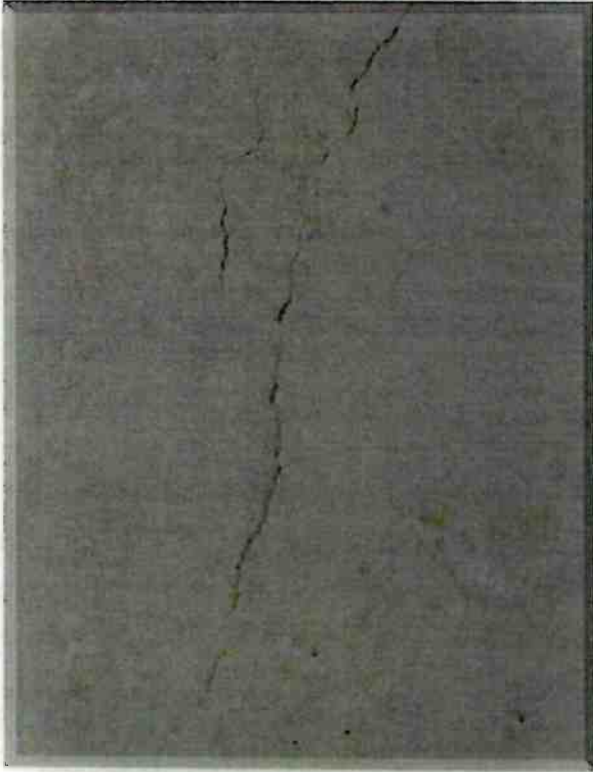
Photo #29 - Unit 405

Concrete Repairs - Beams (Photos 28 & 29)

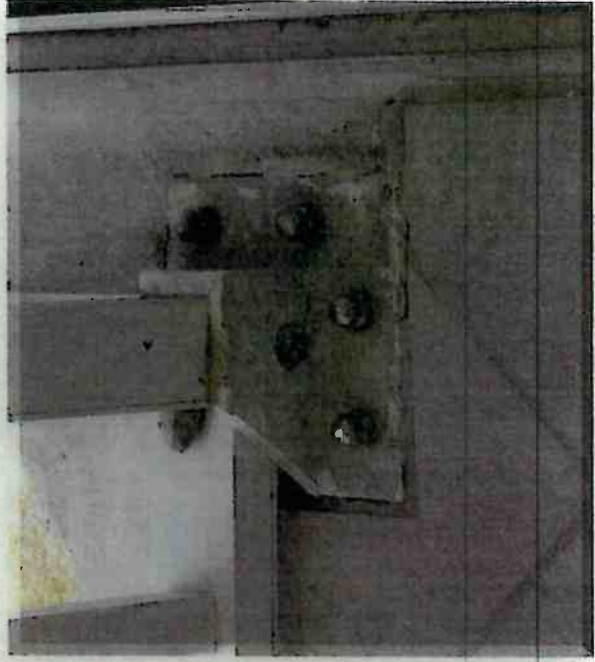
Photo #32 - Unit 601

Although the handrails on the balconies need maintenance, they appear to be in good shape. There are a loose railings, missing fastener bolts, unsealed fastener plates and post pockets needing to be sealed.

LCM recommends these repairs be done sooner than later to mitigate any further damage

to the waterproofing and slab edge. The costs for these repairs is estimated to be \$3,000.

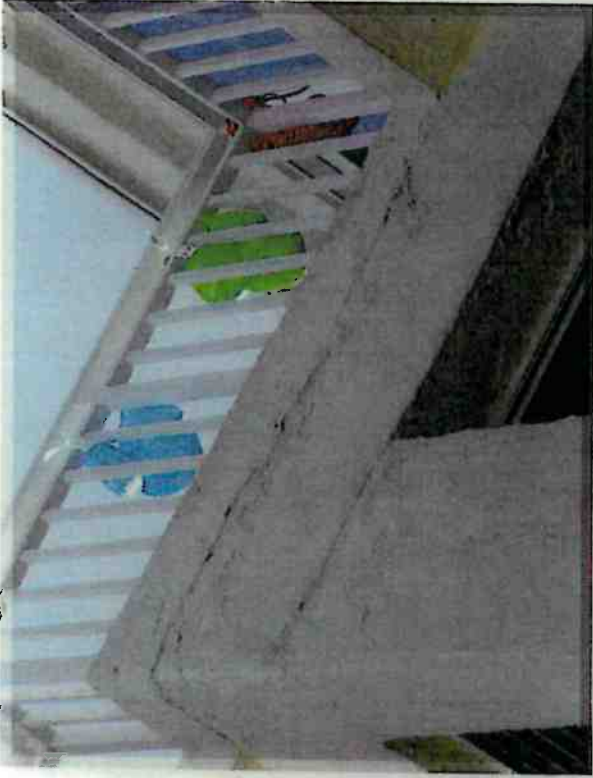
Photo #33 -

Concrete Repairs - Other (Photos 33 & 34)

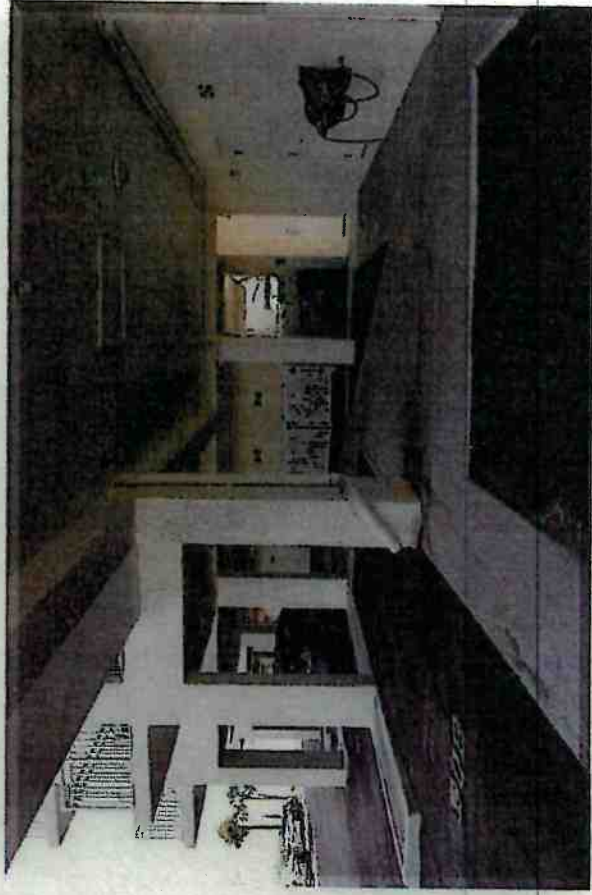
Photo #55 - Exterior

Painting (Photos #55, #57-59)

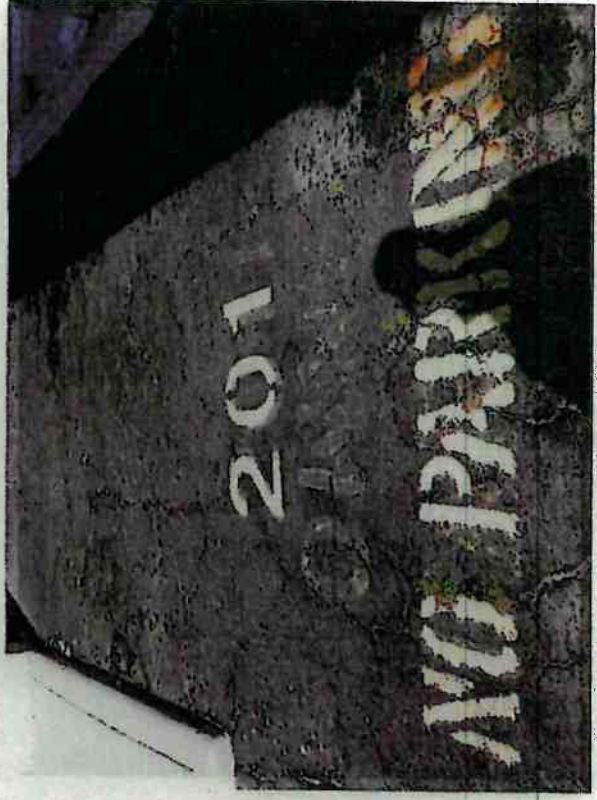
Photo #63 -

Concrete Repairs - Ground Floor Columns (Photos #63, #69-71)

DESCRIPTION	SCHEDULE	ESTIMATED COST
Concrete repairs: Including ground floor columns, upper floor columns and beams, walkway and balcony surfaces.	Less than 3 years	\$300,000
Rooftop Air Conditioner Compressors: install proper anchorage and new raised aluminum frames	Less than 1 year (Sooner is Better)	\$40,000
Roofing: Install fasteners in the interior areas of the existing roofing	Less than 1 year (Sooner is Better)	\$20,000
Re-Roofing: Replace the single-ply roofing membrane	3 to 5 years	\$120,000
Parking: Replace Asphalt	Less than 1 year	\$20,000
Ground Floor: Repair curbs, sidewalk renovations. Replace concrete walkways with pavers.	Less than 1 year	\$100,000
Exterior Painting: Including painting doors & windows, re-caulking door and window frames, and special cleaning and painting at EFIS.	1 to 2 years	\$140,000
Mechanical: Repair split system A/C in the elevator equipment room as needed to ensure proper operation.	Less than 3 months	Unk

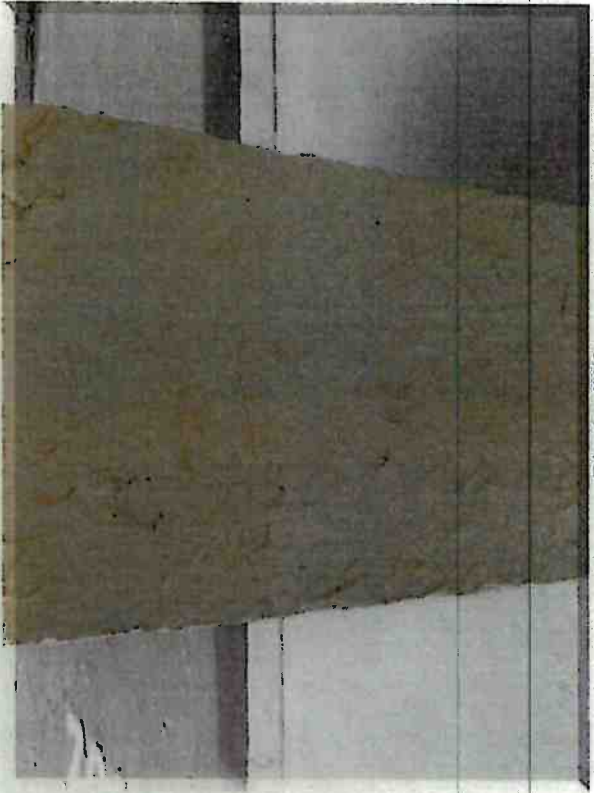
Photo #68 -

Miscellaneous (Photos #68, #72-74)

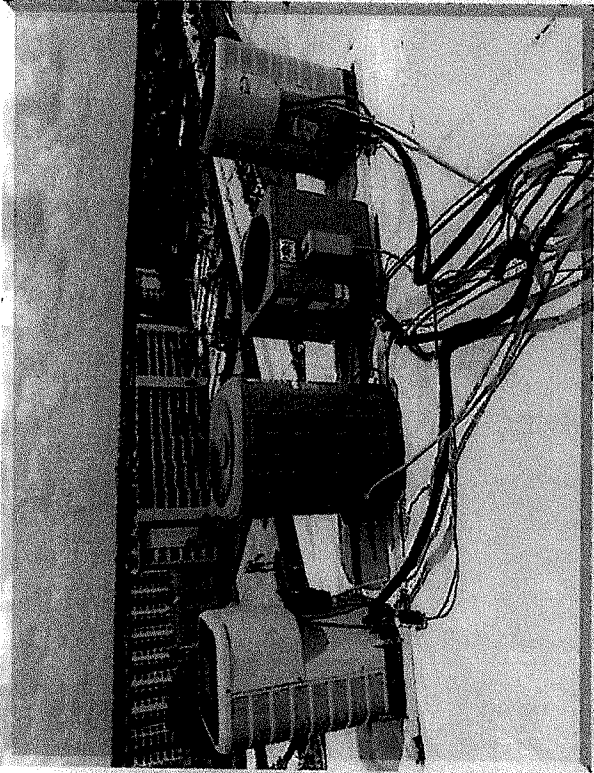
The air conditioning compressor units installed on the roof are not anchored to the roof. High winds will likely dislodge the compressors resulting in loss of air conditioning and potential loss of the compressors over the edge of the roof. See photo #77. Electrical and refrigerant lines penetrating through the roof to the compressors are poorly anchored. See photo #78.

Photo 77 - Compressors are anchored to runners, but runners are not anchored to the roof.

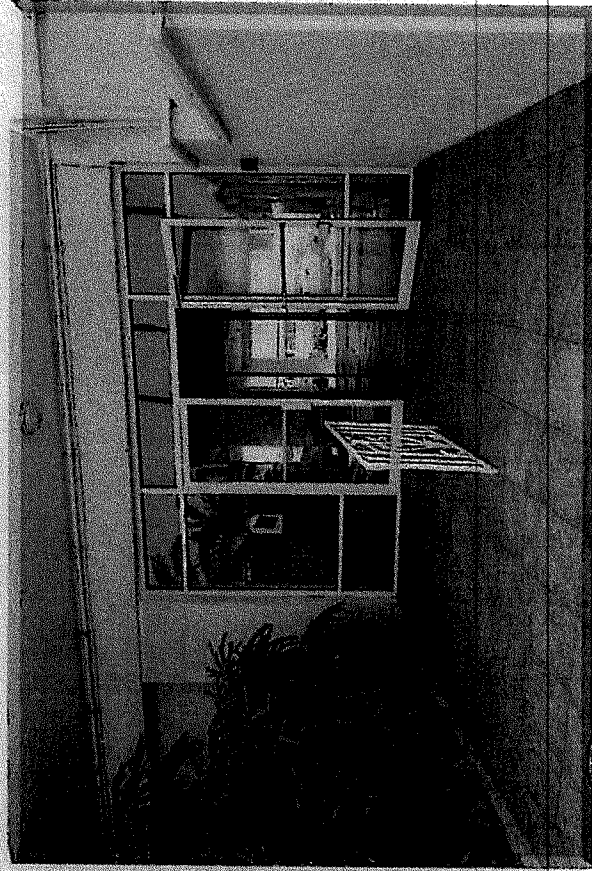
Photo 80 - Lobby - North Entry
